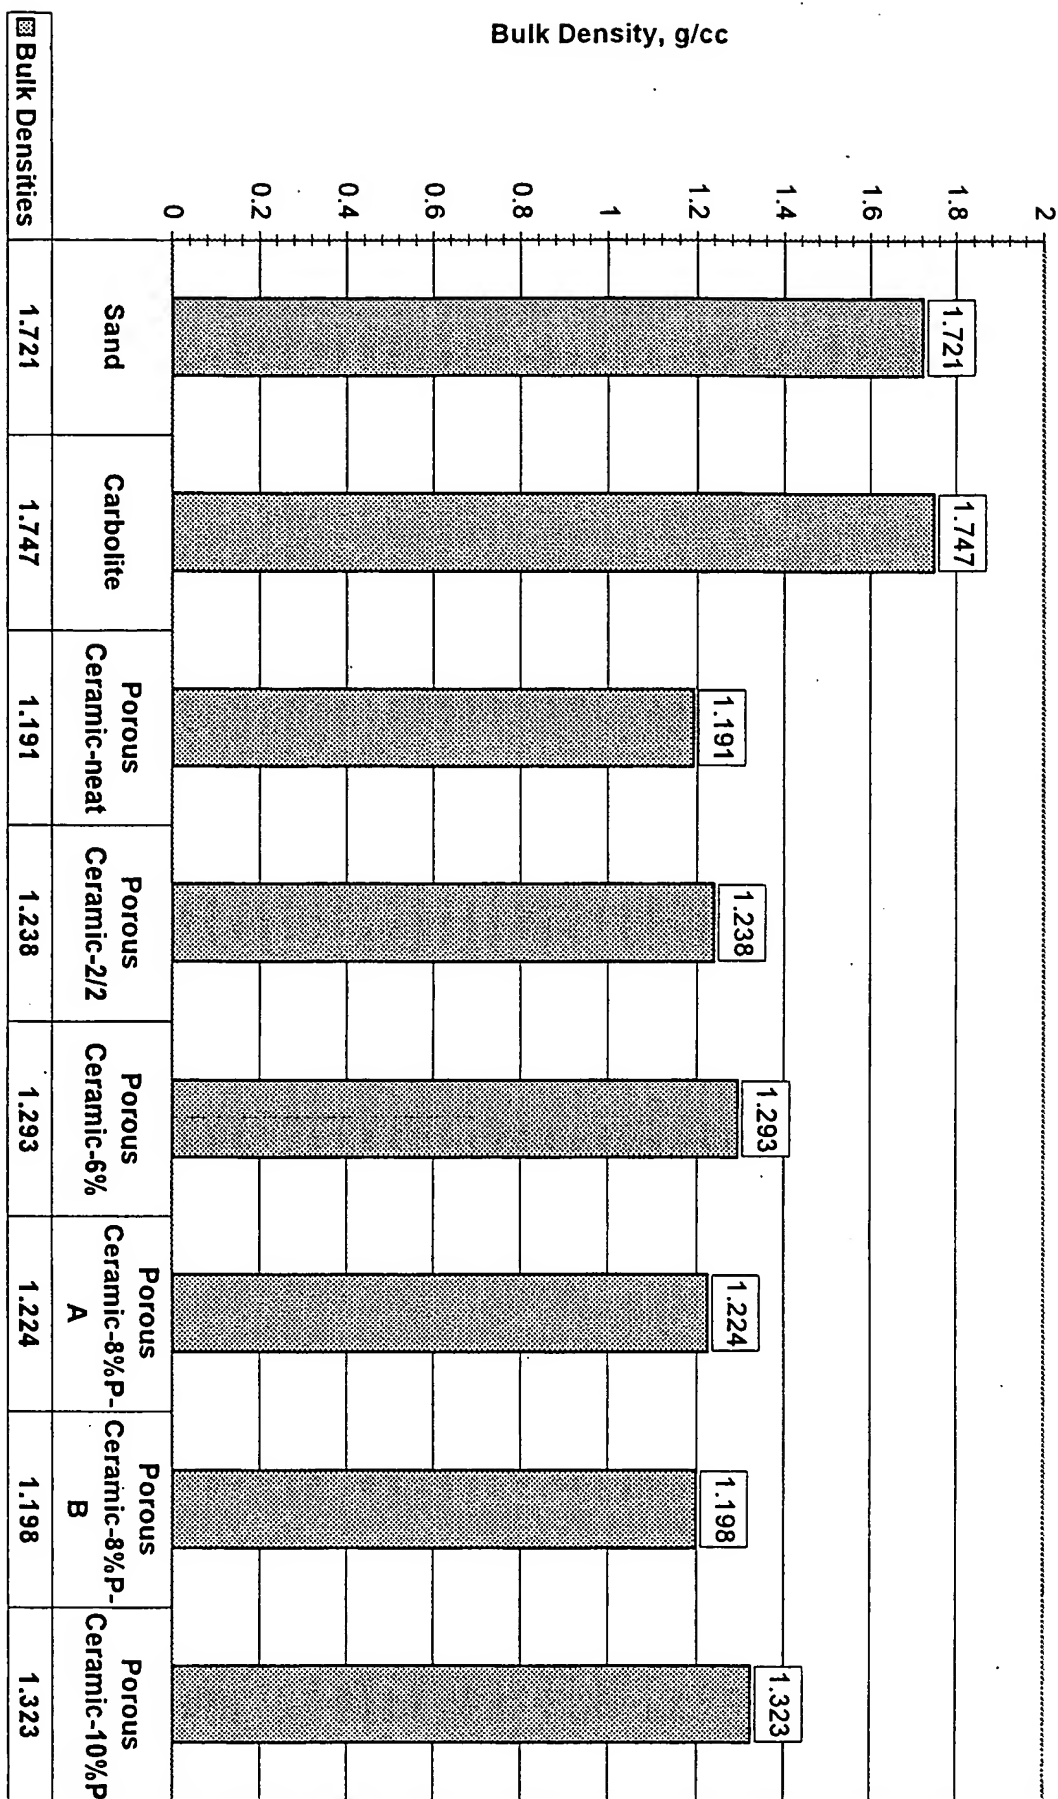
FIG. 1

Bulk Densities

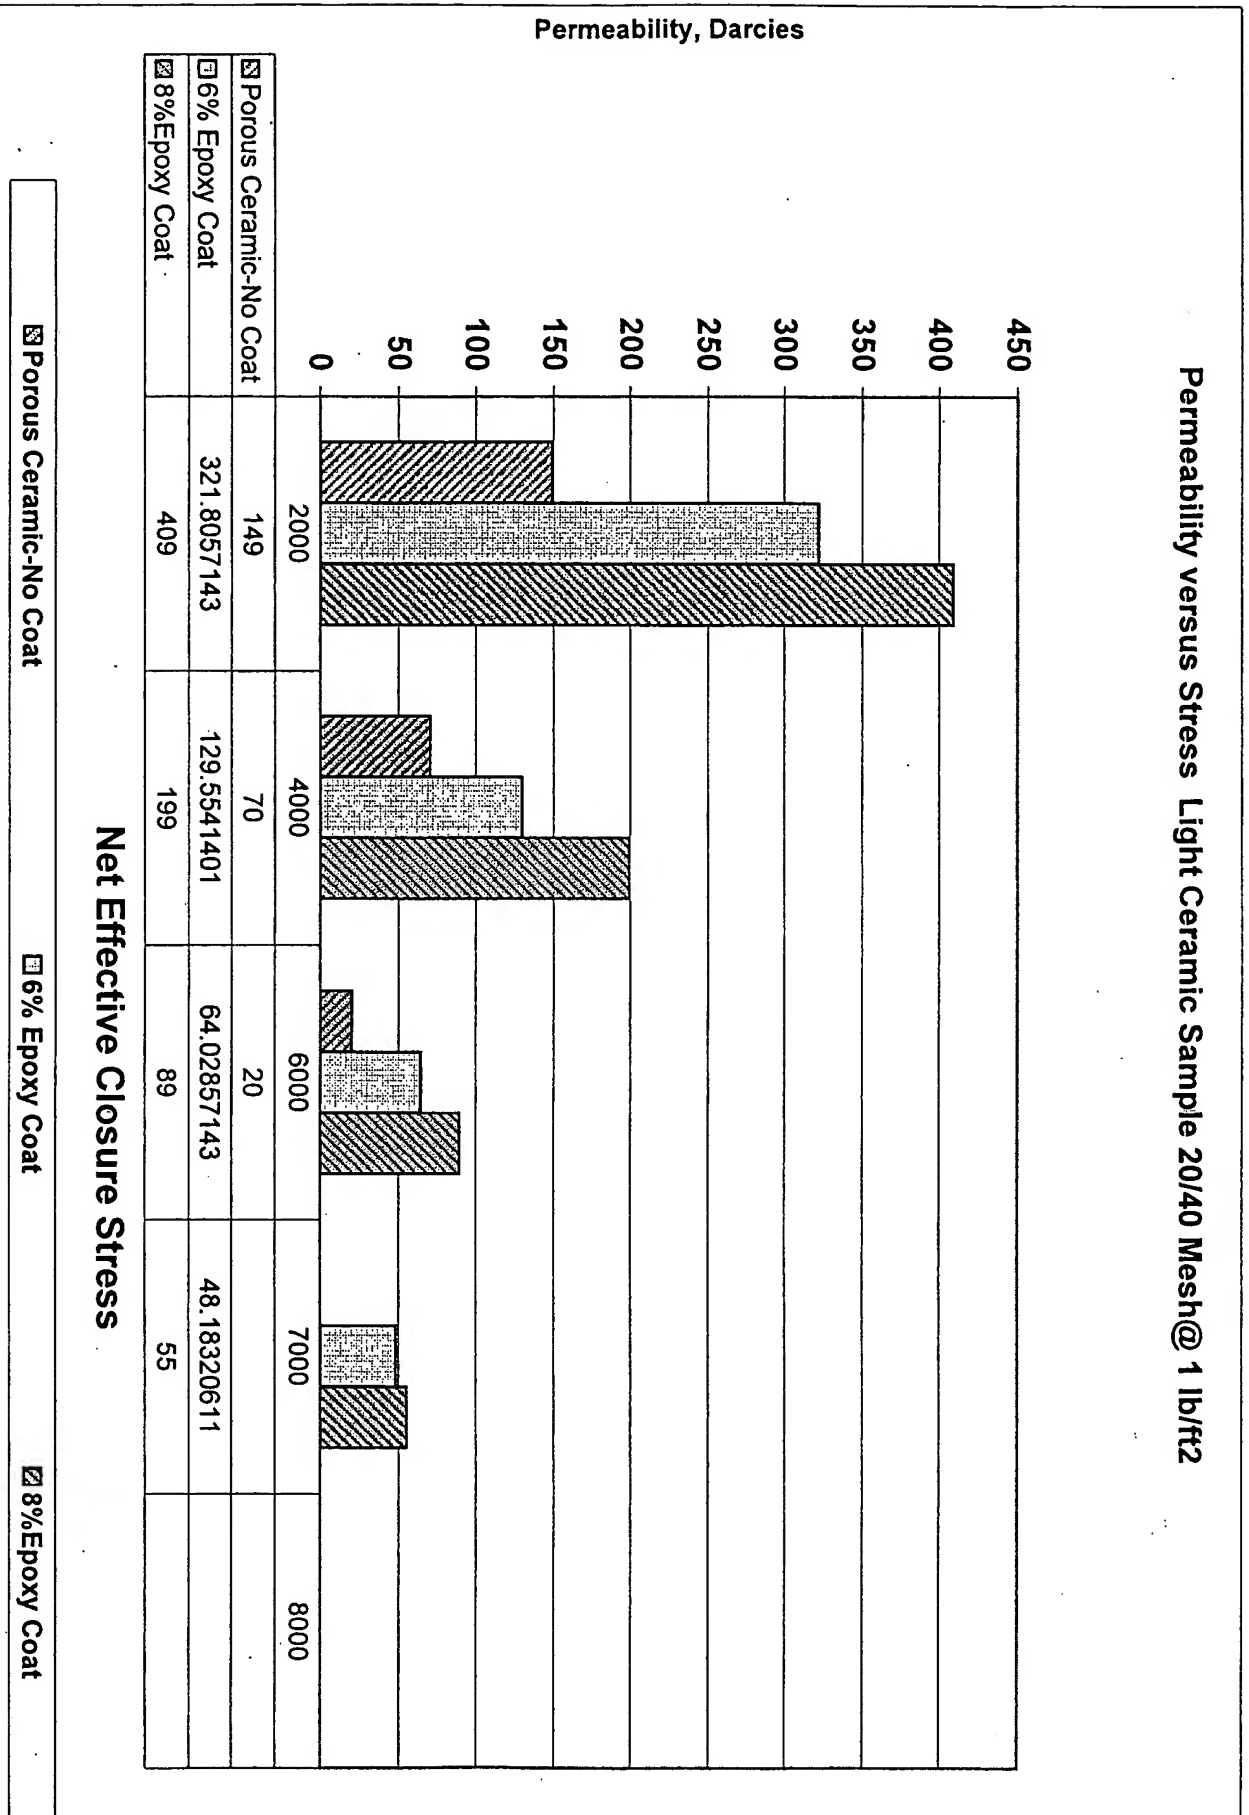
FIG. 2

Permeability versus Stress Light Ceramic Sample 20/40 Mesh@ 1 lb/ft²

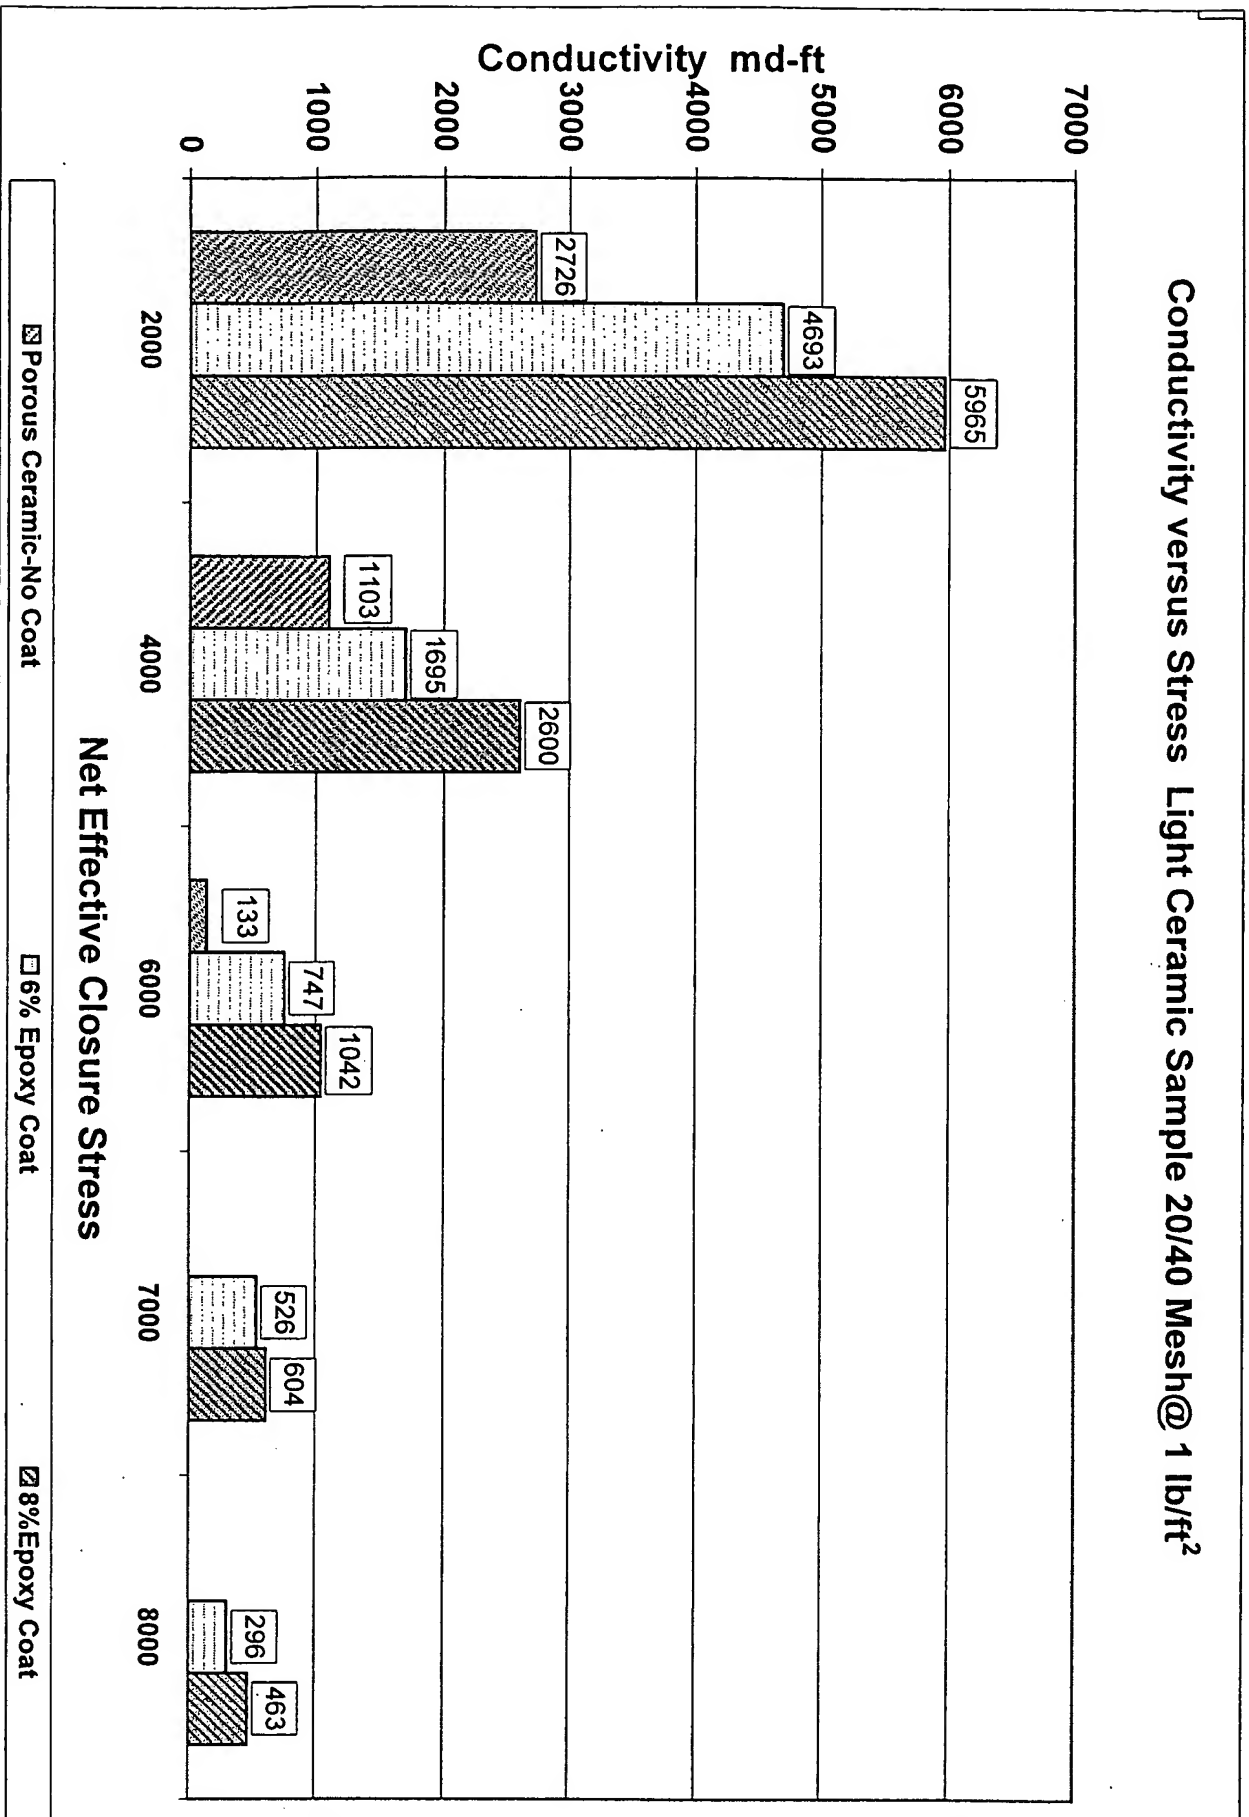
FIG. 3

Conductivity versus Stress Light Ceramic Sample 20/40 Mesh@ 1 lb/ft²

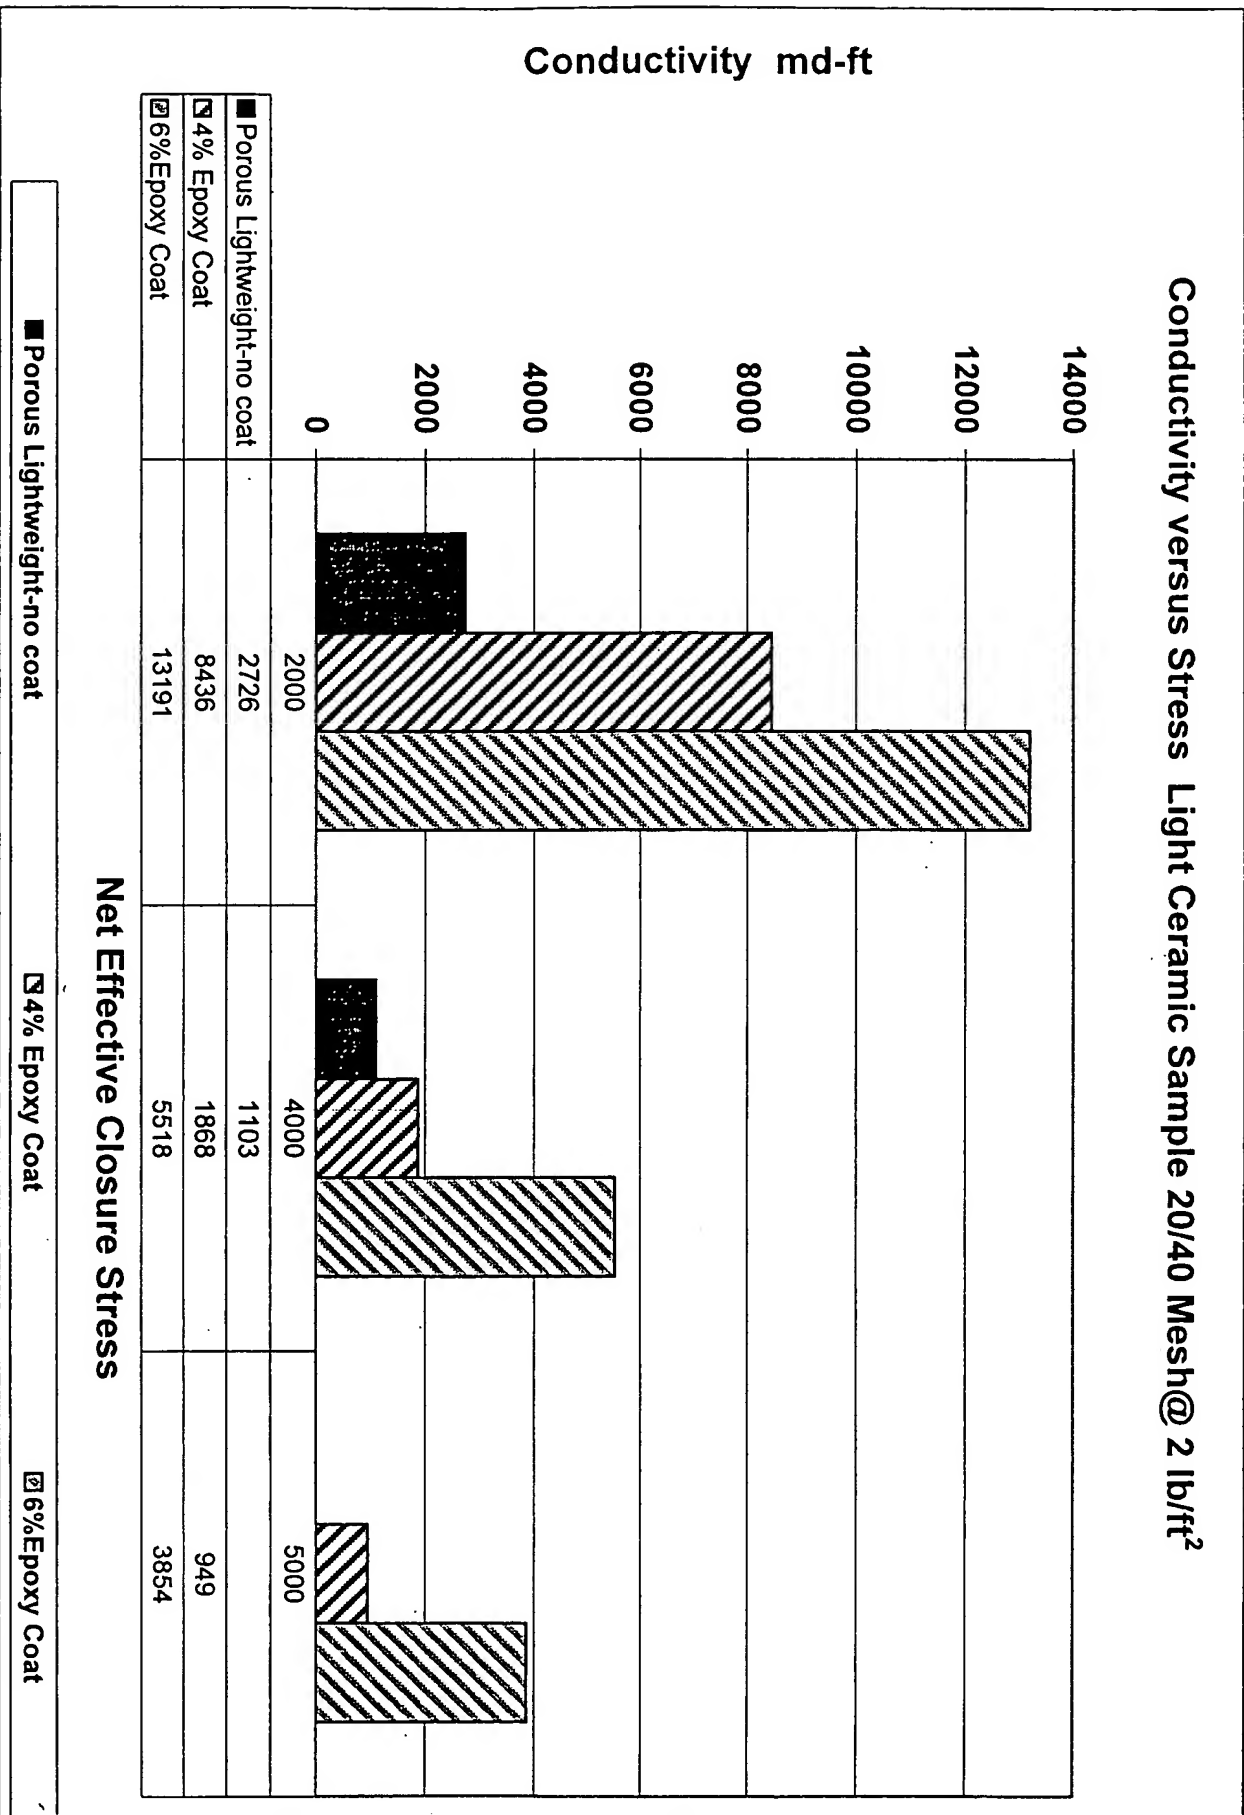
FIG. 4

Conductivity versus Stress Light Ceramic Sample 20/40 Mesh@ 2 lb/ft²

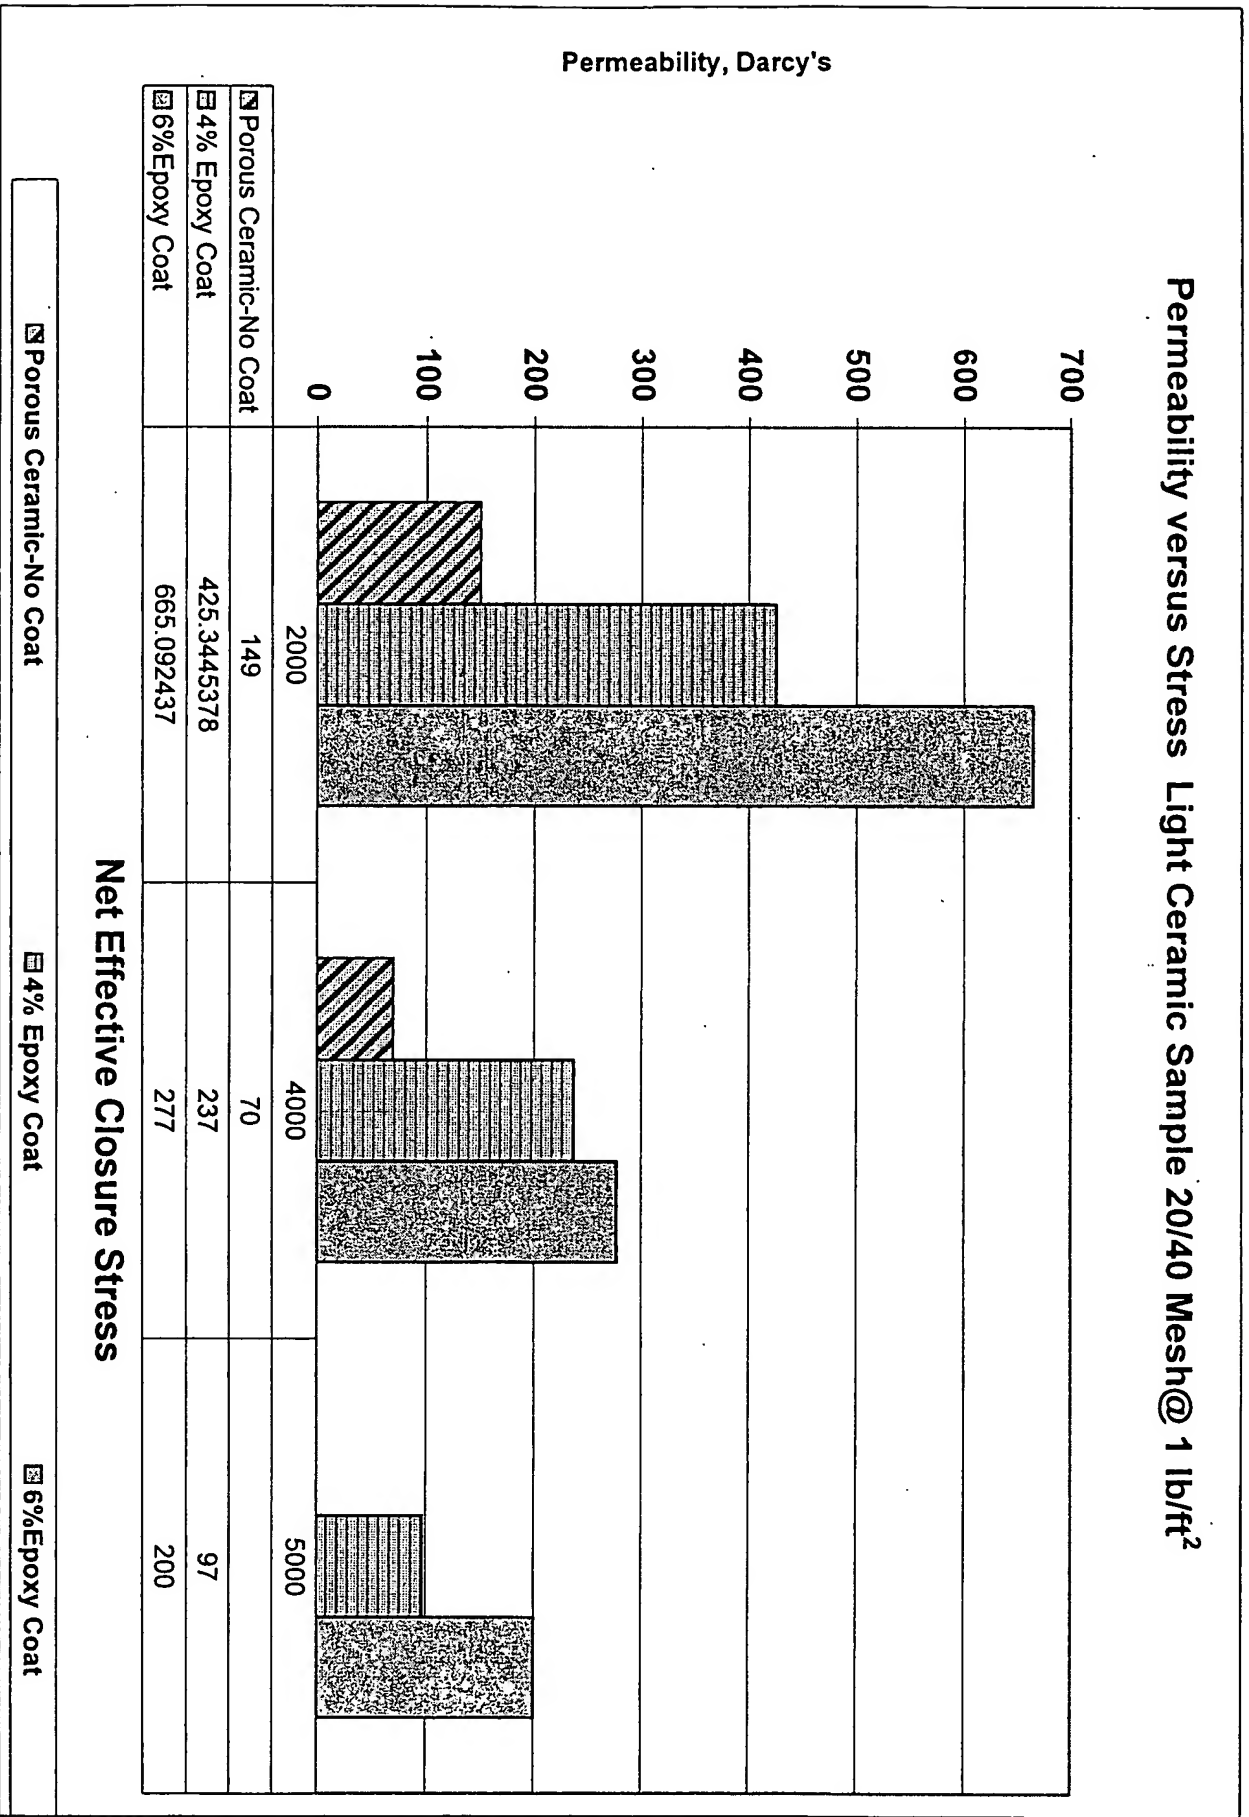
FIG. 5

Permeability versus Stress Light Ceramic Sample 20/40 Mesh@ 1 lb/ft²

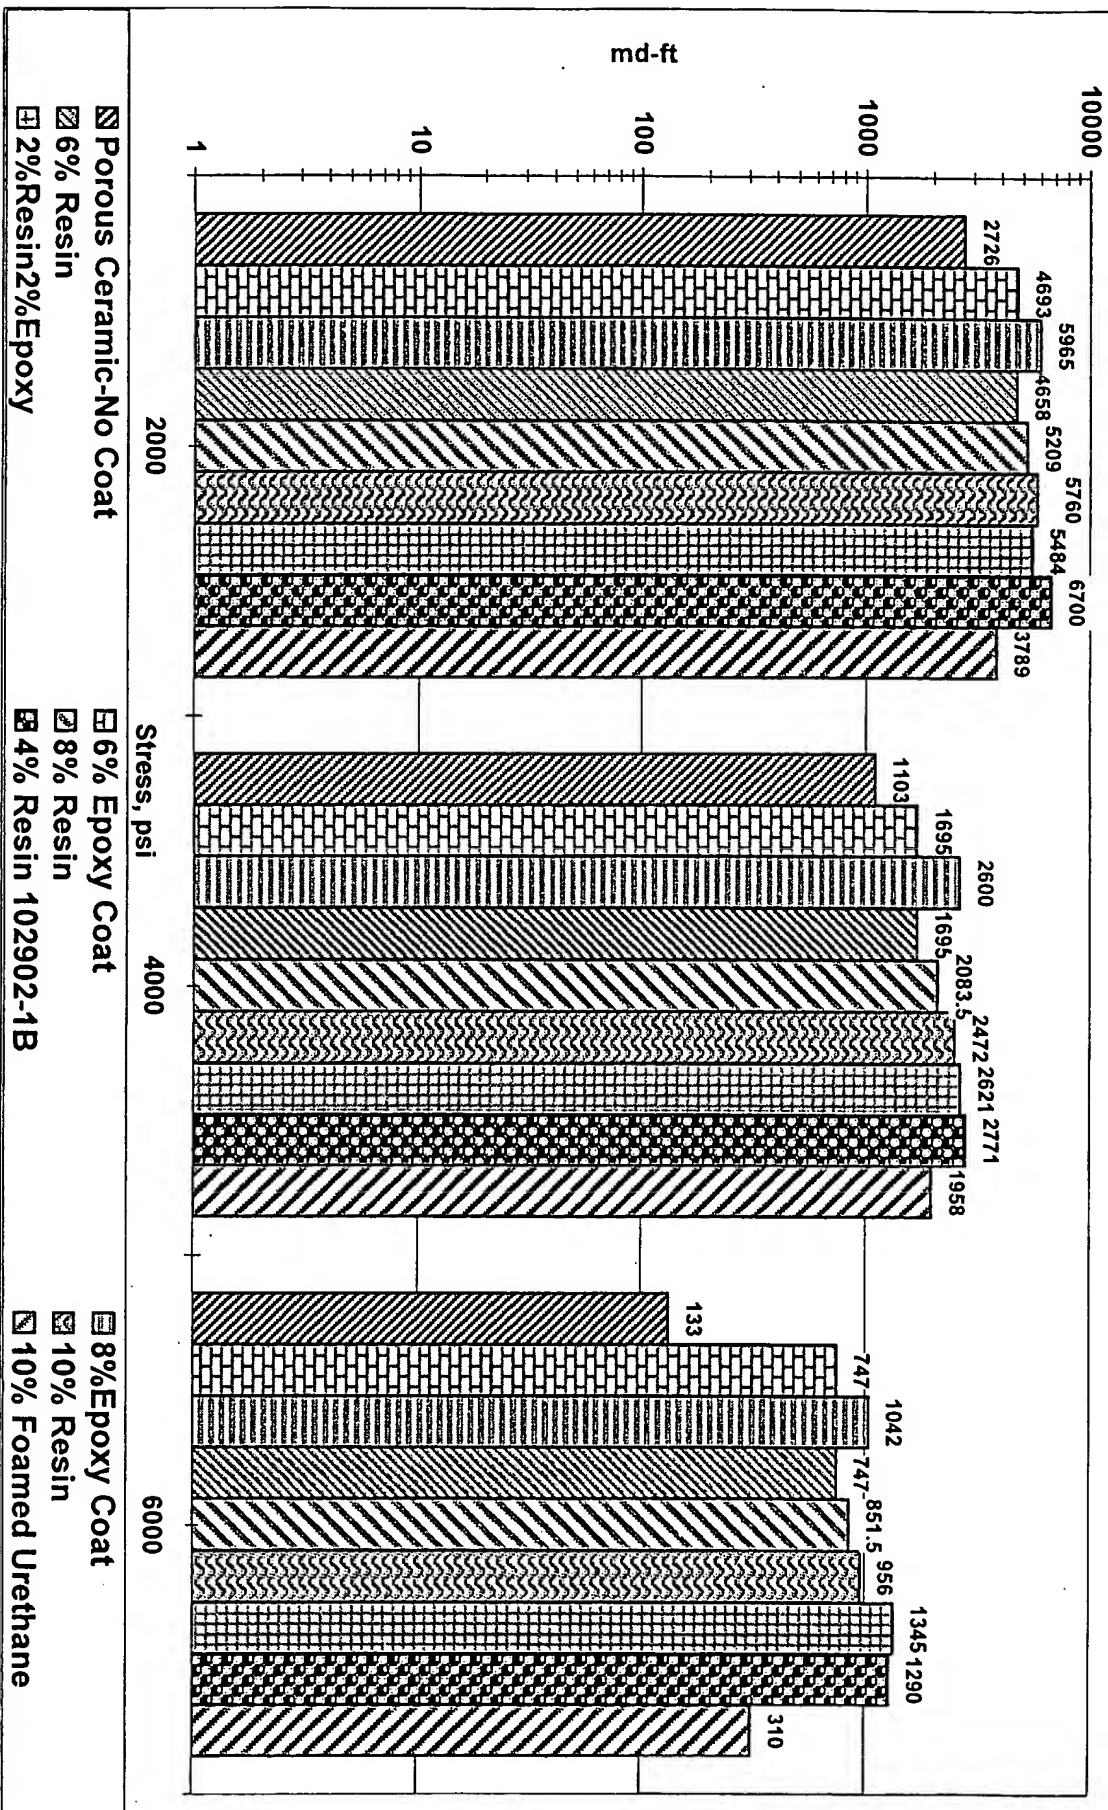
FIG. 6

Porous Lightweight Ceramic Conductivity vs. Resin/Epoxy @ 1lb/ft²

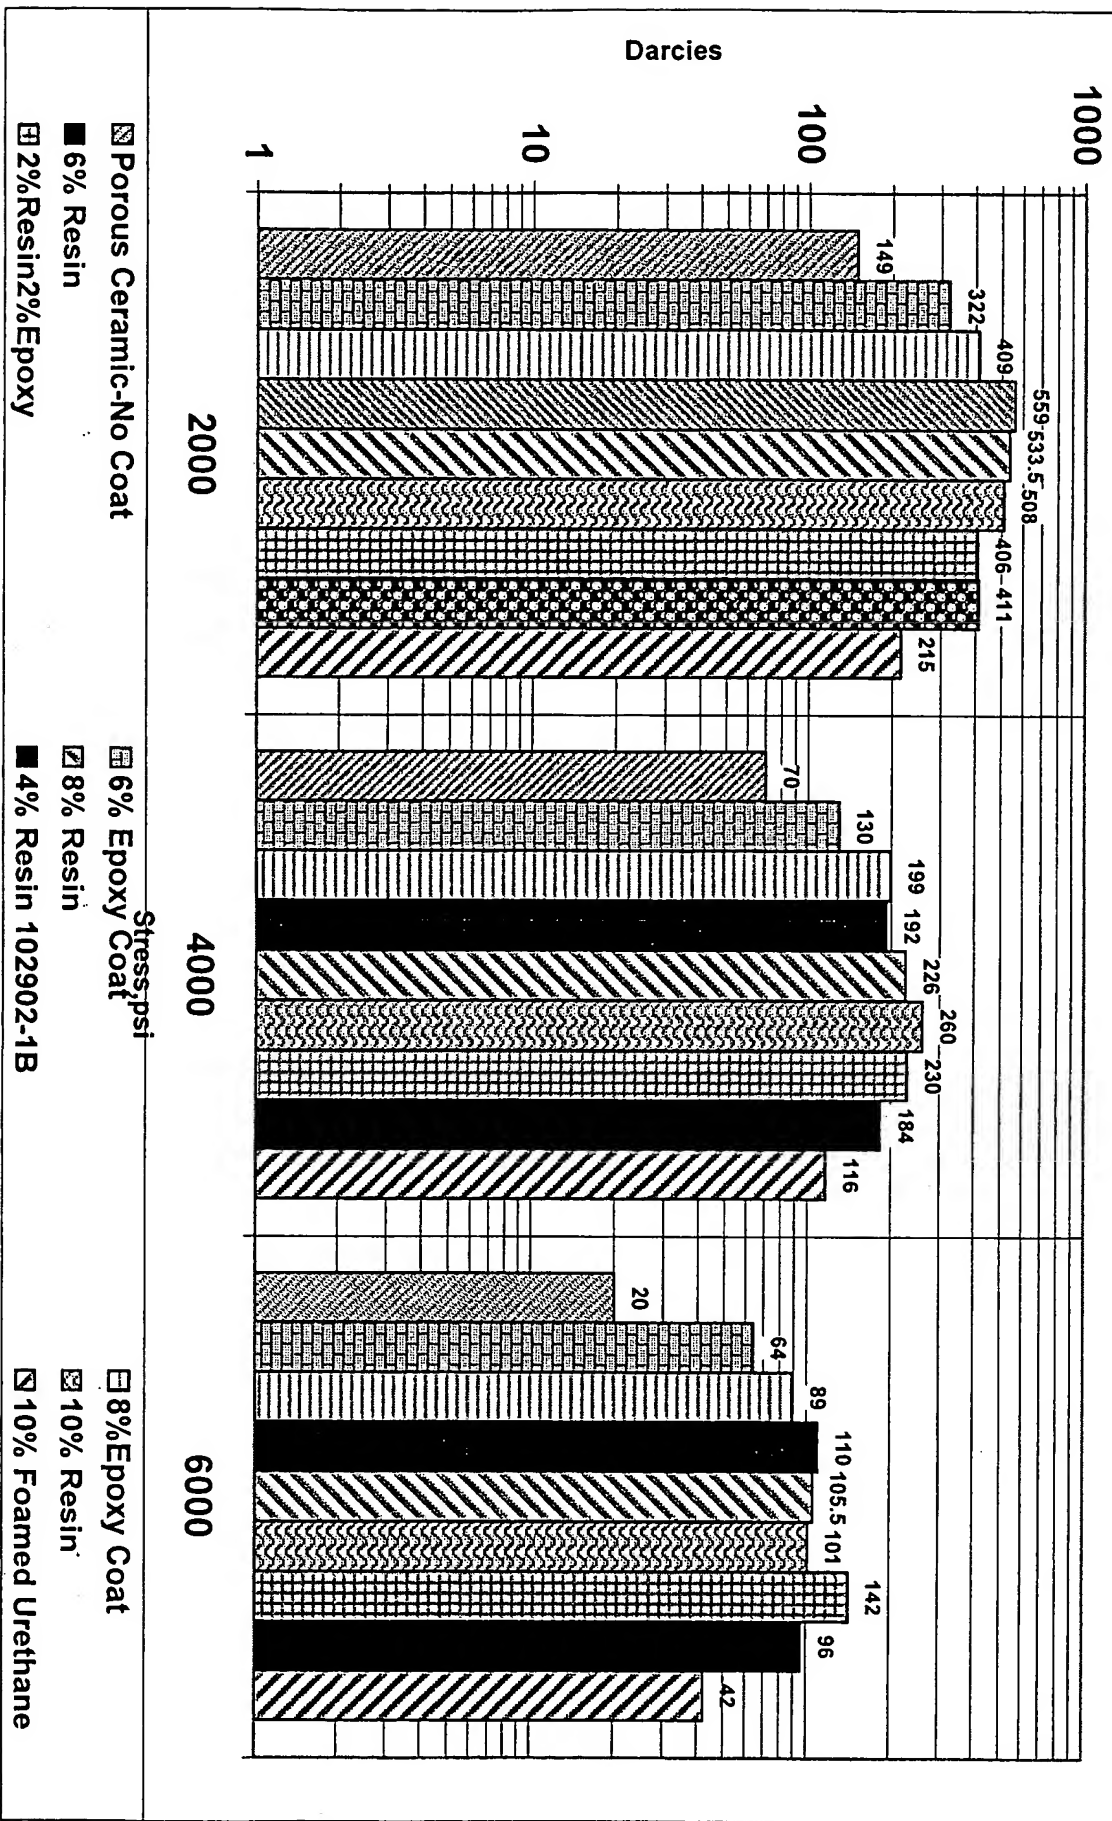
FIG. 7

Porous Ceramic Permeability vs Resin/Epoxy @ 1lb/ft²
